## Test Report

No. SHAEC2012933801

The following sample(s) was/were submitted and identified on behalf of the clients as : Brake pad

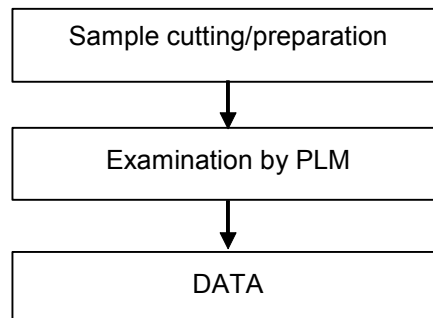
### Asbestos Testing Flow Chart

Test Method : With reference to NIOSH 9002:1994, Analysis was performed by Polarized light microscope (PLM).

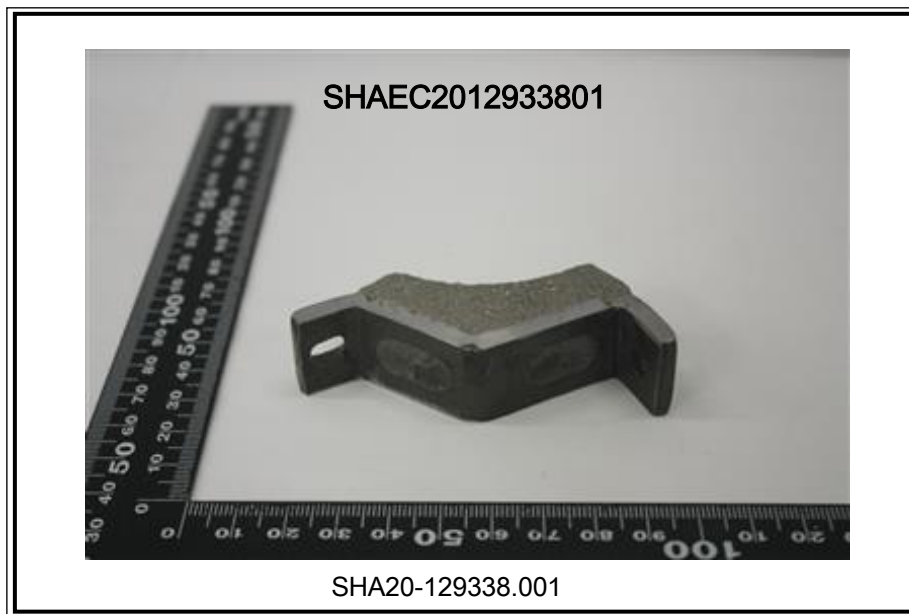
Sample photo:

Specimen No.	SGS Sample ID	Description
SN1	SHA20-129338.001	Silver/grey metal
